Manhole Inspection Summary

Manhole # S13YY1009MH

Insp Date: **10/18/06 3:49 PM**

Location Address: **5604 GREENSPRING AVE**

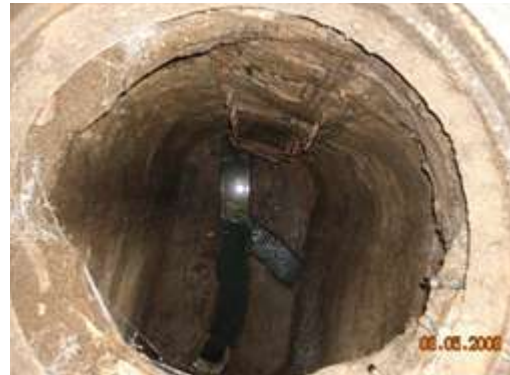
Top View

Corroded and missing steps. Evidence of surcharge - Bench debris. Channel debris.

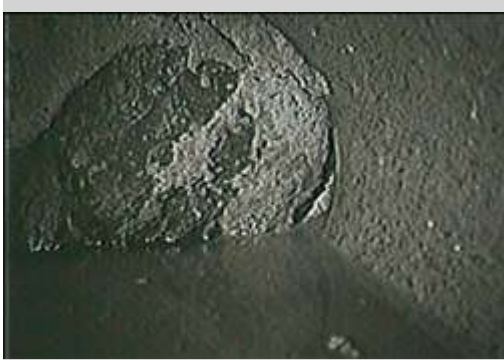
Inside the I4

Pipe is plugged.

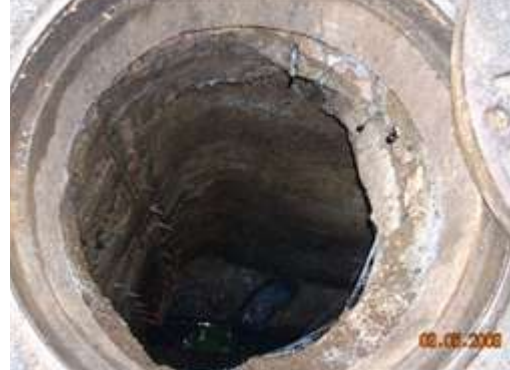
Defect

Frame leaks. Frame offset. Adjustment deterioration and infiltration. Corbel and Barrel infiltration - other side.

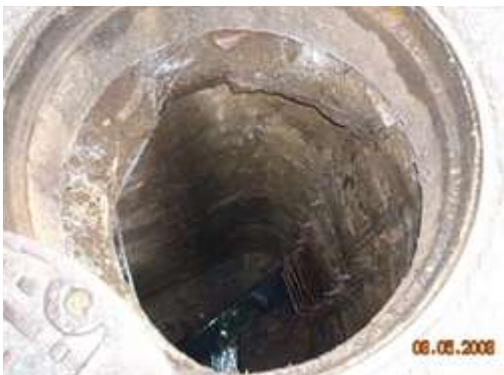
Defect

Frame leaks. Frame offset. Adjustment deterioration and infiltration. Corbel and Barrel infiltration.

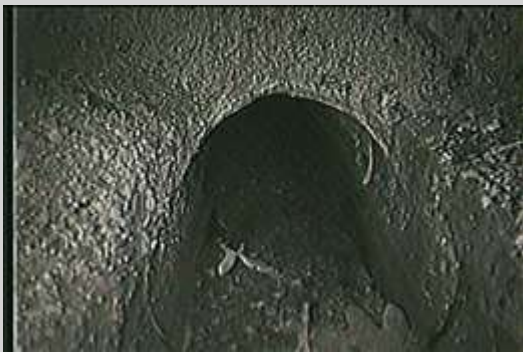
8 in. Circular Gravity Sewer Pipe Out @ 12 O'Clock

Deposits: ☐ None ☒ **Mud** ☐ Sludge ☒ **Debris** ☐ Grease

Silt Depth: **2** (in.) Deposits Extent: **Light**

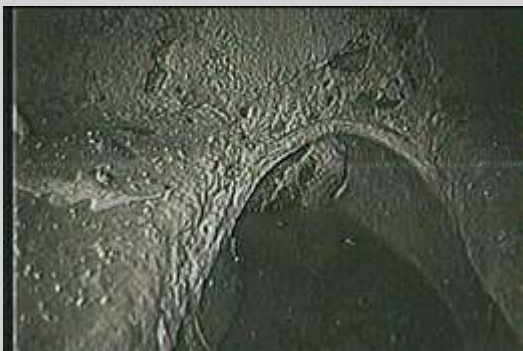
8 in. Circular Gravity Sewer Pipe In @ 4 O'Clock

Plugged.

Connects To: **Stub connection / abandoned**

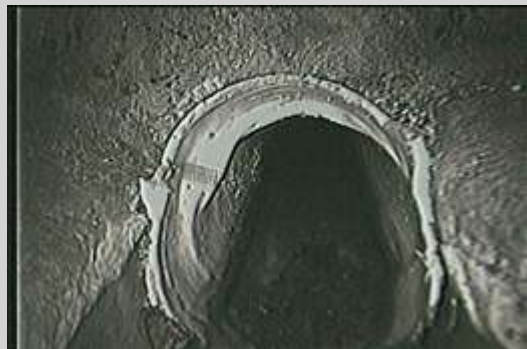
Pipe In @ 7 O'Clock

Deposits: ☐ None ☒ **Mud** ☐ Sludge ☒ **Debris** ☐ Grease

Silt Depth: **1** (in.)

Deposits Extent: **Light**
